Technical Report CHL-97-30  
October 1997

# **Navigation Conditions at Point Marion Lock and Dam, Monongahela River**

## **Hydraulic Model Investigation**

Final report

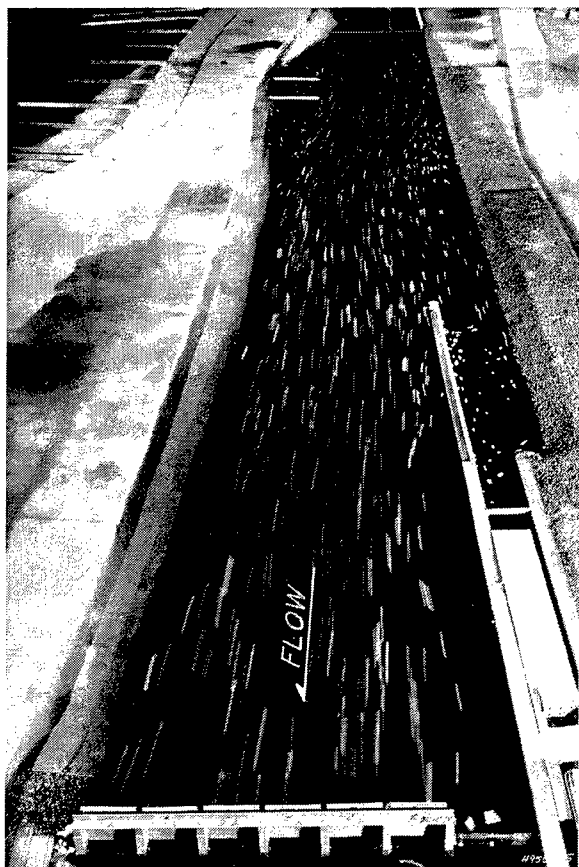
Photo 9. Plan B, looking upstream, discharge 22,500 cfs, confetti showing surface current patterns in the upper approach to the lock

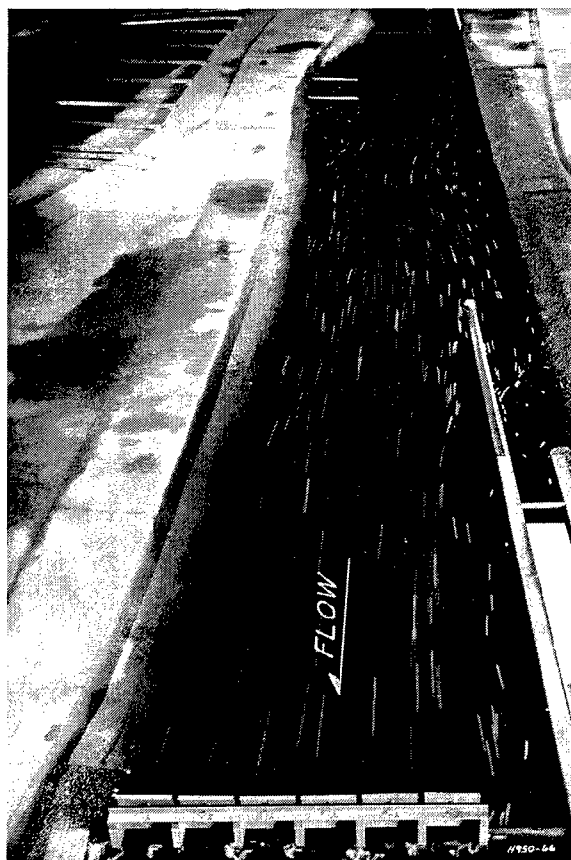
Photo 10. Plan B, looking upstream, discharge 33,000 cfs, confetti showing surface current patterns in the upper approach to the lock

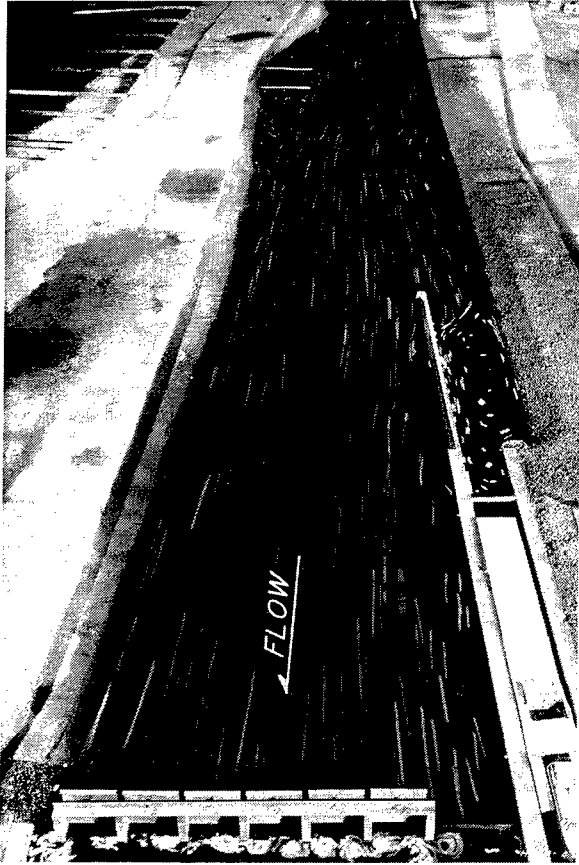
Photo 11. Plan B, looking upstream, discharge 55,000 cfs, confetti showing surface current patterns in the upper approach to the lock

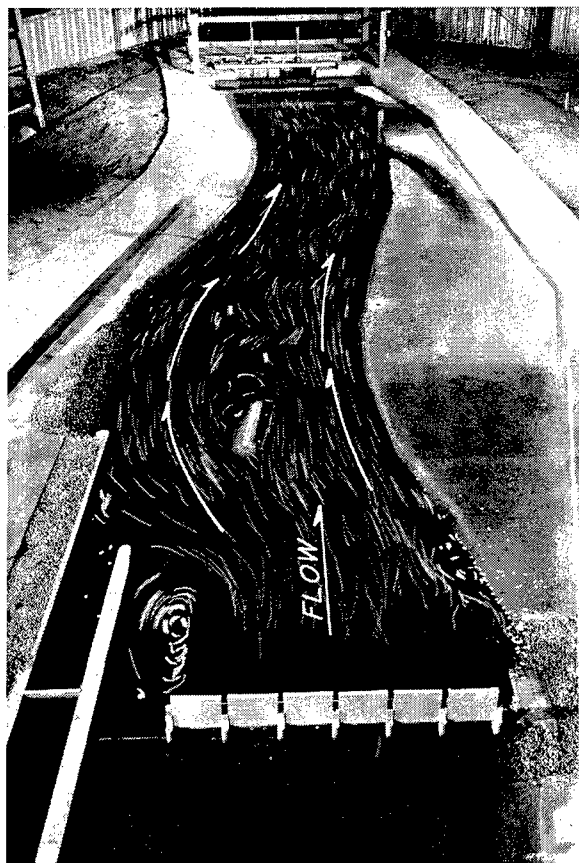
Photo 13. Plan B, looking downstream, discharge 33,000 cfs, confetti showing surface current pattern in the lower lock approach

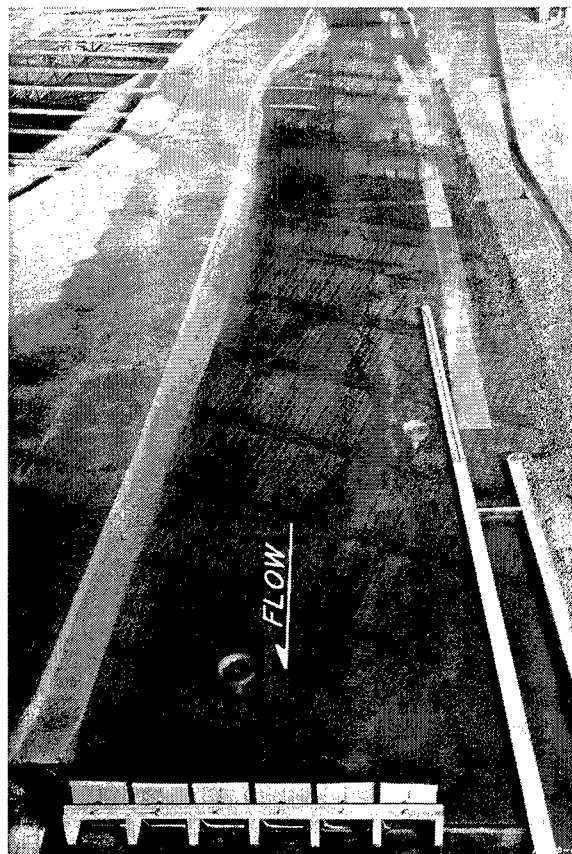
Photo 14. Plan B, looking upstream, discharge 55,000 cfs, showing path of downbound tow approaching lock along left bank

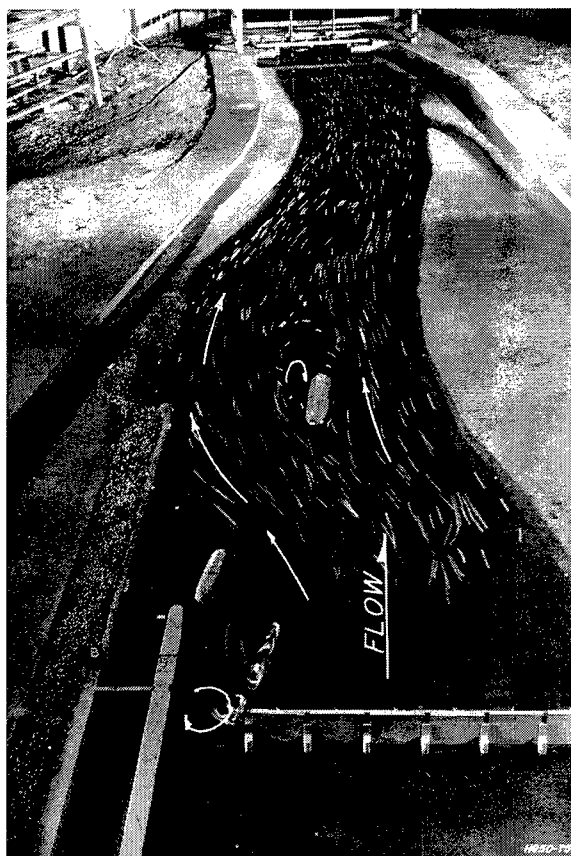
Photo 22. Plan B-Modified, looking downstream, discharge 22,500 cfs, confetti showing surface current patterns in the lower approach to the lock

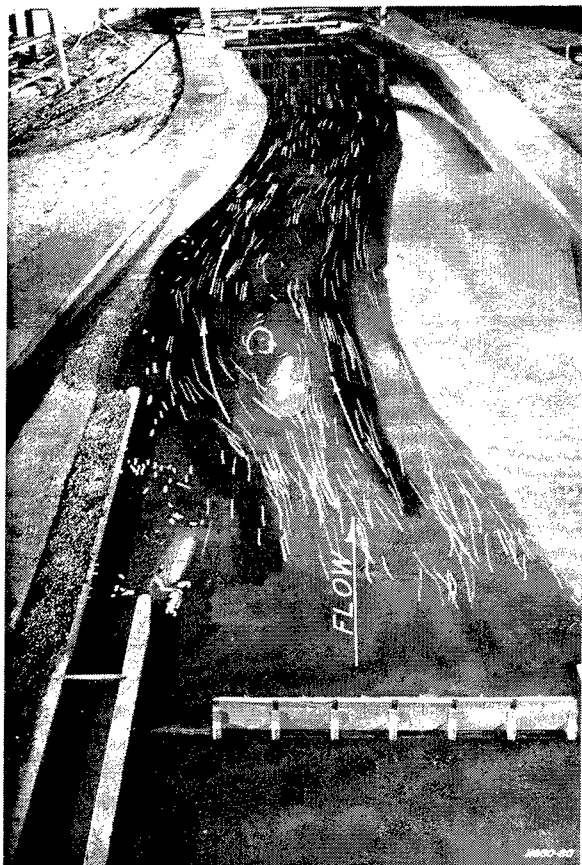
Photo 23. Plan B-Modified, looking downstream, discharge 55,000 cfs, confetti showing surface current patterns in the lower approach to the lock

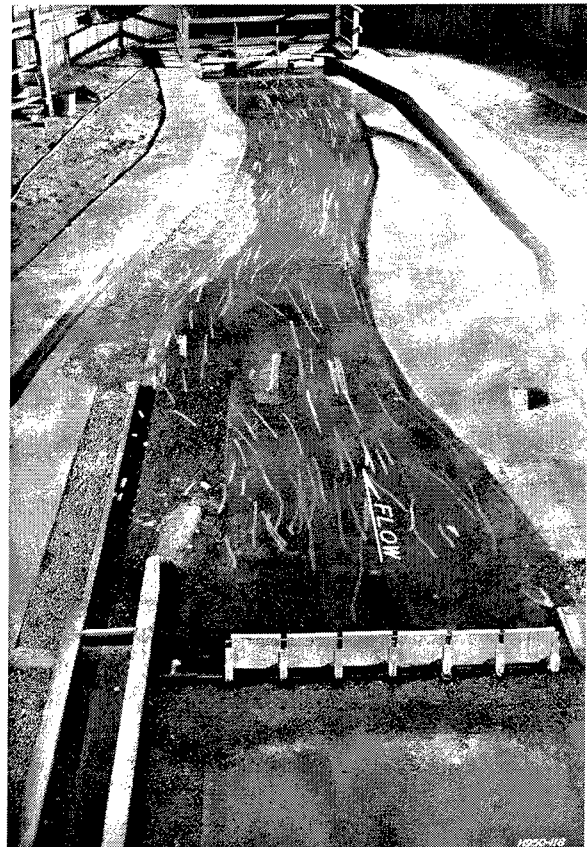
Photo 43. Plan E, looking downstream, discharge 22,500 cfs, confetti showing surface current patterns in lower lock approach

**Current directions and velocities.** Current direction and velocities obtained with Plan E are shown in Plates 16-18. Current patterns upstream of the dam are shown in Photos 41 and 42, and current patterns downstream of the dam are shown in Photos 43 and 44. These data indicate that the current generally followed the left bank from the upstream end of the model to the upstream end of the left bank excavation where the current tended to follow the main river channel. The vane dikes located near the right bank reduced the cross-sectional area of the river channel near the upstream end of the left bank excavation and moved the current into the excavated channel. The current was erratic in the vicinity of the vane dikes. However, this disturbance did not extend into the navigation channel approaching the lock. The maximum velocities of the current in the navigation channel varied from about 3.1 to 5.6 fps near the upstream mooring area, 3.3 to 6.1 fps about 1,500 ft upstream of the guard wall, and 2.2 to 3.7 fps near the upstream end of the guard wall. Current direction and velocity data shown in Plates 16-18 and current patterns shown in Photos 43 and 44 indicate the currents downstream of the dam were generally the same as with Plan B-Modified. These data indicate that the flow through the spillway moved between the vane dike near the end of the riverside lock wall and the vane dike near midchannel and across the lower lock approach at a steep angle. Some flow passed through the opening between the vane dike and the downstream end of the riverside lock wall. However, a small counter-clockwise eddy formed immediately downstream of the lock chamber with the 22,500- and 33,000-cfs riverflows. The velocity of the current in the eddy was generally less than 0.5 fps. The maximum velocities of the current near the downstream end of the guide wall varied from about 3.6 to 5.5 fps with the 22,500- and 55,000-cfs riverflows, respectively. The maximum velocities of the current in the navigation channel downstream of the lock varied from about 3.8 to 4.6 fps about 2,000 ft downstream of the dam and 3.6 to 4.2 fps about 4,000 ft downstream of the dam with the 22,500- and 55,000-cfs riverflows, respectively.

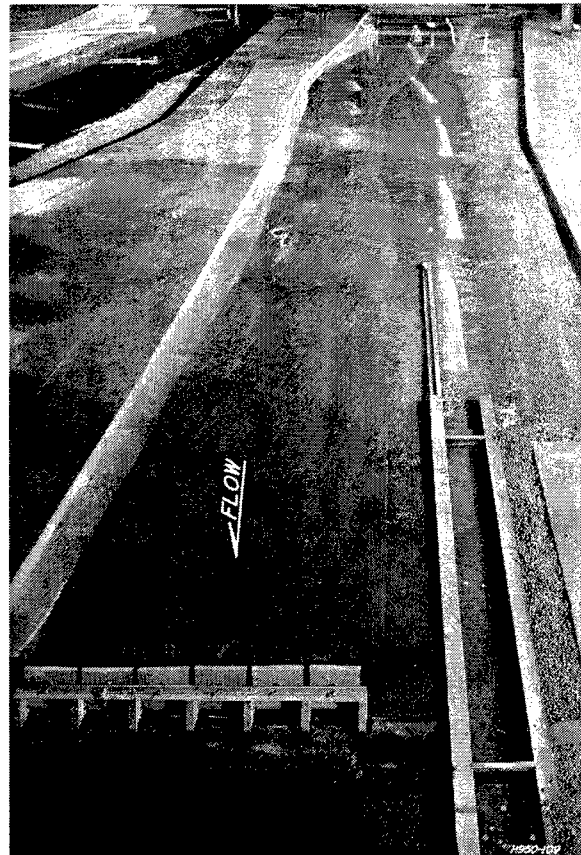
Photo 45. Plan E, looking upstream, discharge 22,500 cfs, showing path of downbound tow approaching lock

**Navigation conditions.** Navigation conditions were satisfactory for tows entering and leaving the upper lock approach with all riverflows up to the maximum navigable flow of 55,000 cfs (Photos 45-48). A downbound tow could enter the model reach from midchannel, drive into the excavated channel, align with the guard wall about two tow lengths upstream of the wall, start reducing speed, and enter the lock forebay at a safe speed with all riverflows through 55,000 cfs (Photos 45 and 46). The tow could make a slow approach to the guard wall without any tendency to be moved out of the approach or for the head of the tow to move into the wall with excess force. No difficulties were indicated for upbound tows leaving the lock. An upbound tow could move away from the guard wall and navigate upstream along the left bank or move out into the main channel without any difficulties (Photos 47 and 48). Although the design for the lower lock approach did not provide a full tow length of straight channel approaching the guide wall, navigation conditions for tows entering and leaving the lower lock approach were satisfactory with all flows. However, downbound tows were required to rotate the head of the tow away from the guide wall about 15 deg before leaving the lower approach. After rotating the head of the tow off the guide wall, the tow could drive away from the lower

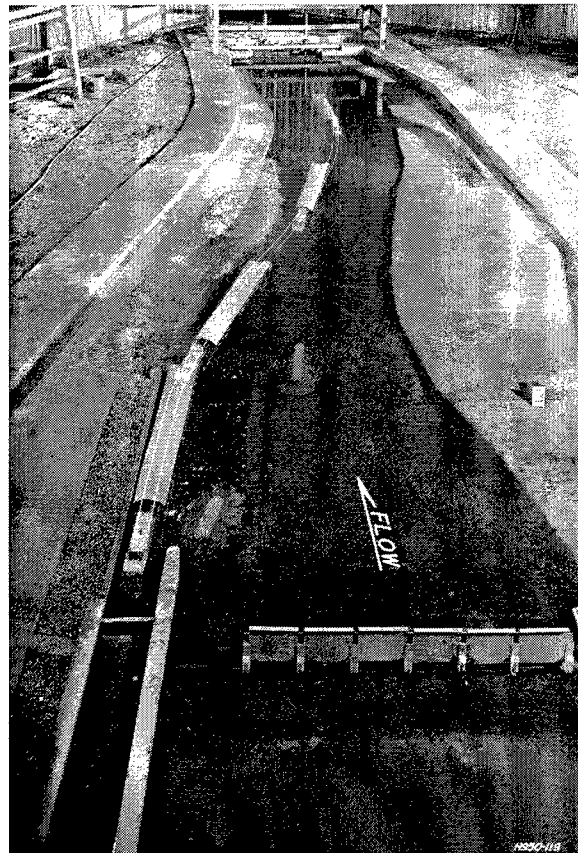
Photo 49. Plan E, looking downstream, discharge 22,500 cfs, showing path of downbound tow leaving lock

approach and enter the main channel without any difficulties (Photos 49 and 50). Maneuvering the head of the tow away from the guide wall would require additional time but was not a difficult maneuver. If the tow moved downstream without maneuvering the head of the tow off the wall, the clearance between the tow and the left bank was minimal for the tow to turn toward the main river channel. Upbound tows could leave the main river channel, align with the guide wall, and enter the lock chamber without any difficulties (Photos 51 and 52). There was no tendency for the head of the tow to move away from the guide wall as the tow entered the lock chamber.
